LOUISIANA DEPARTMENT OF WILDLIFE & FISHERIES

WATERBODY MANAGEMENT PLAN SERIES

SALINE LAKE

LAKE HISTORY & MANAGEMENT ISSUES

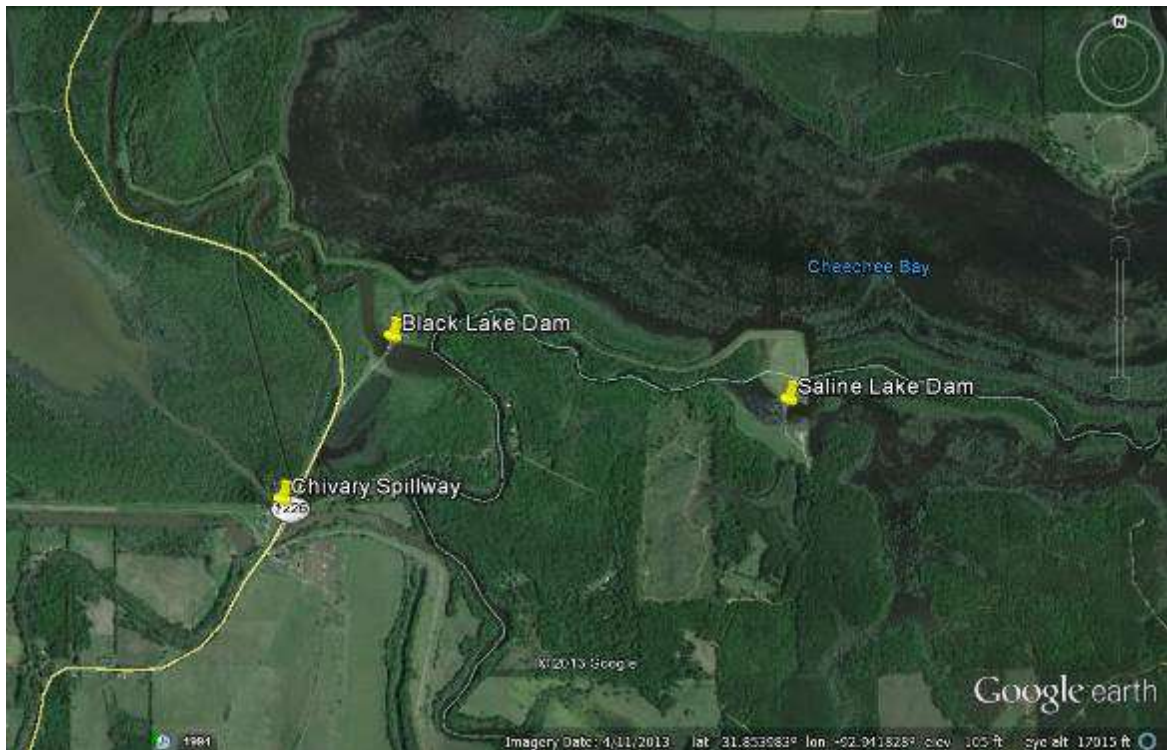
Figure 2. Map of Saline Lake Dam, located Winn and Natchitoches Parishes, LA.

The Saline Lake Dam is located 8 miles NE of Clarence, LA in Section 12 and 13, T10N-R6W, in Natchitoches Parish at map coordinates: latitude 31.852564 N and longitude -92.931331 W. A map of the Saline Lake Dam location appears in Figure 2.

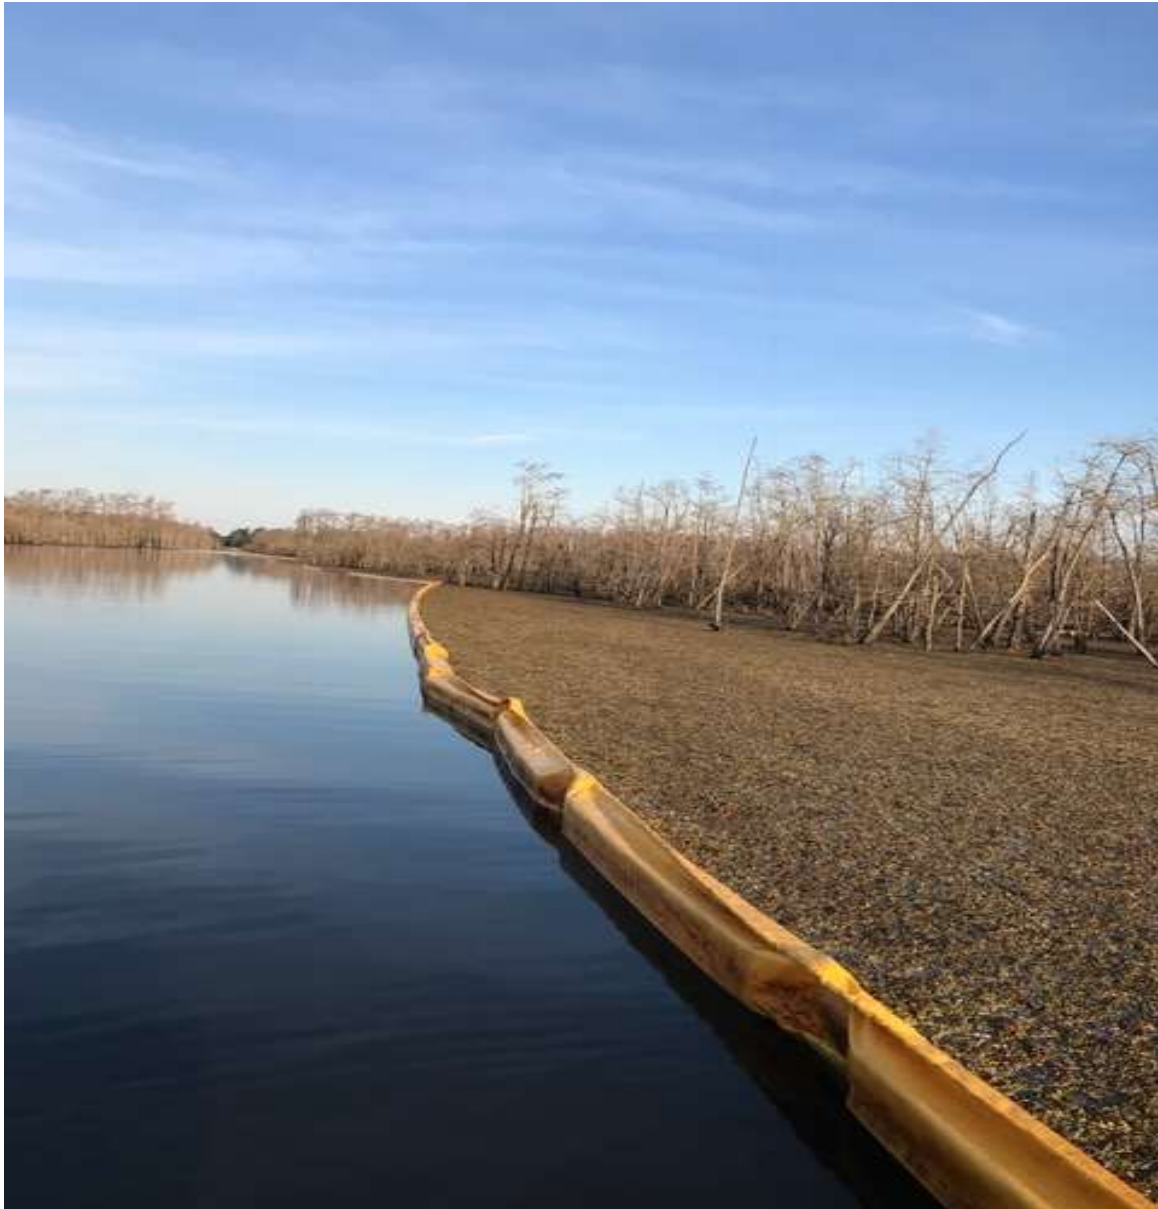
Figure 3. Four thousand-foot vegetation containment boom placed along North side of pipeline above Mulligan Inn Landing.

February 2019, 4,000 feet of boom was placed across the lake along the pipeline above Mulligan Inn Landing (Figure 3). It is being used to contain salvinia from moving into more open areas of the mid to lower-lake where boating access is greatest. The result of the boom placement has been greater access and decreased treatments in the southern areas of Saline Lake, and increased chemical treatments above the boom placement.
